ACCESSIBILITY AUDIT for

Photo Album

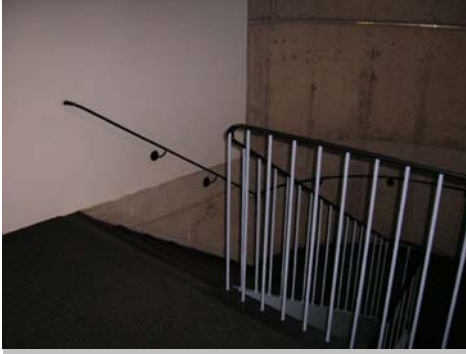
Img 2 2390

A Building A Level 1
2 Stairwell North, Level 1

Handrail

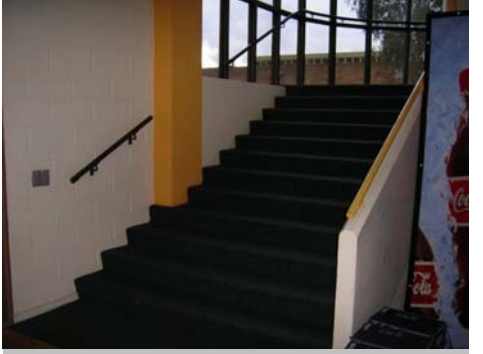
Img 3 2559

B Building B Level 1
3 Stairwell Lvl 1

Handrail Step(s)/Stairway

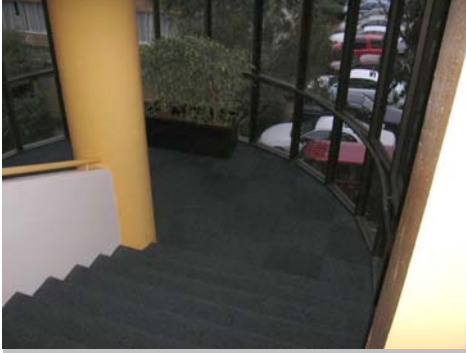
Img 4 1164

B Building B Level 2
4 Stairwell Lvl 2

Emergency Egress feature Hazard Step(s)/Stairway

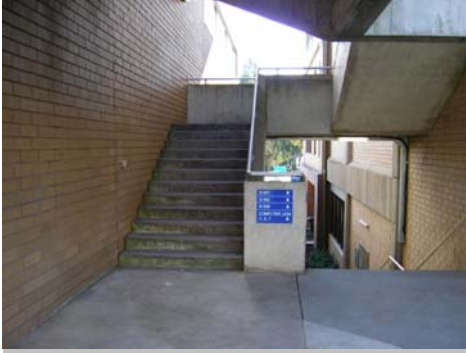
Img 5 2465

B Building B Level 2
5 Fire escape stair from B2 to Plaza 1

Handrail Step(s)/Stairway
